MSFN RELIABILITY A SUMMARY OF THEORY AND RESULTS

F. KALIL
R. WIGAND

JULY 1968

GODDARD SPACE FLIGHT CENTER
GREENBELT, MARYLAND

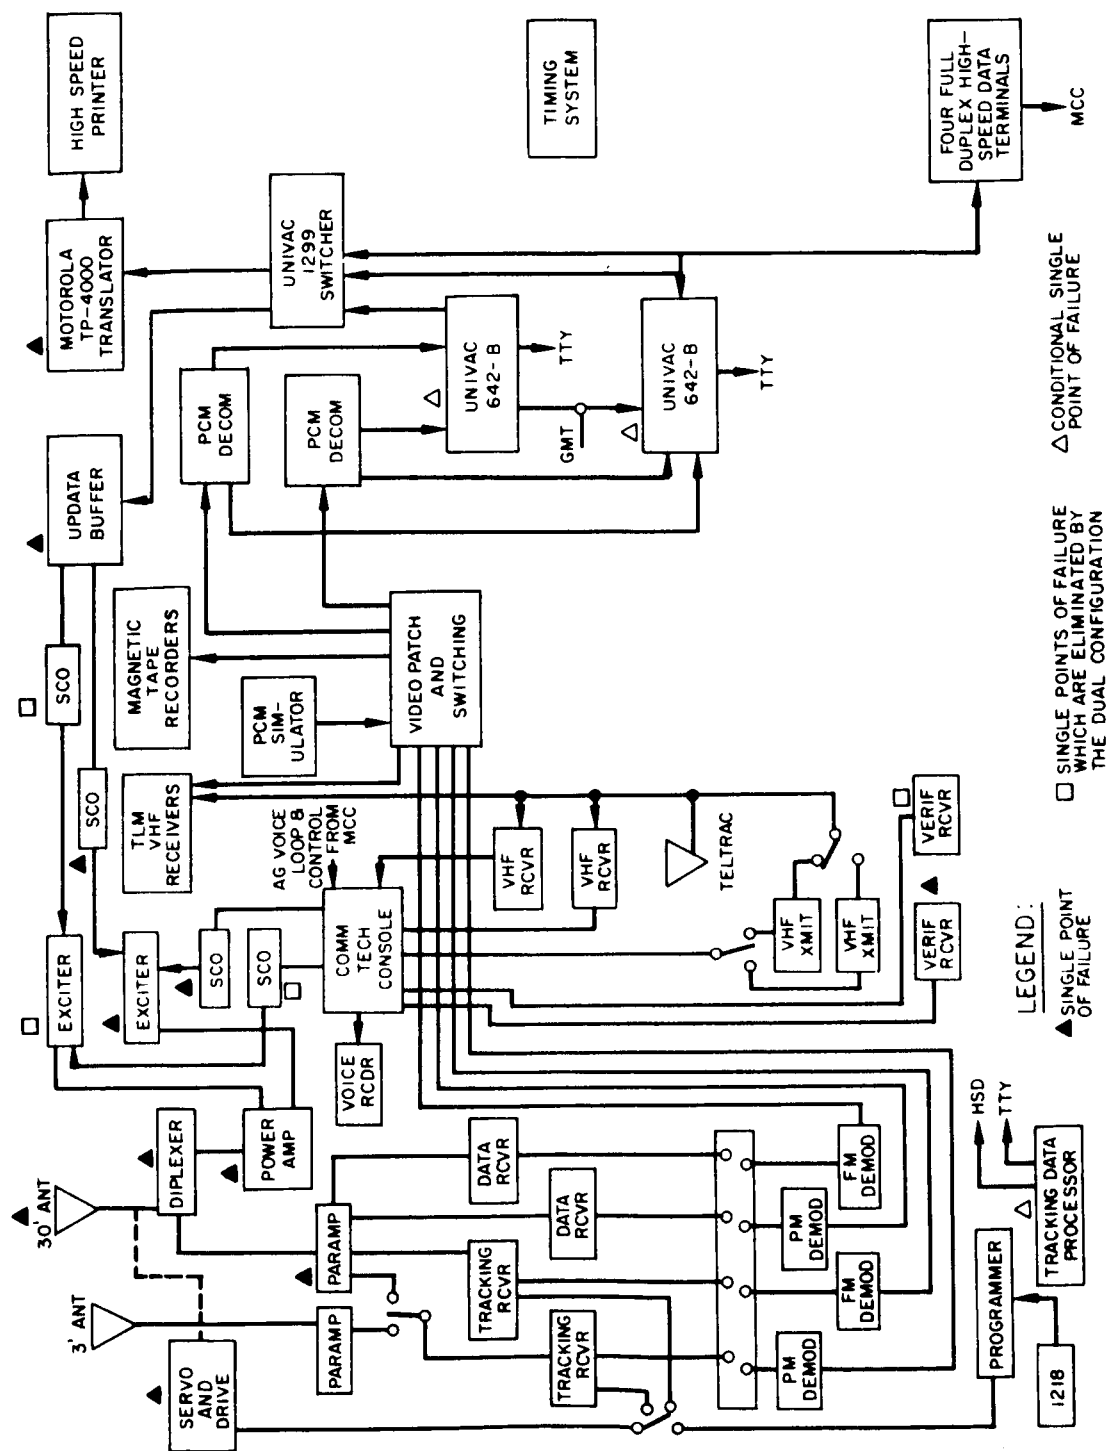
Figure 4-Single Points of Failure for a USB System

In Table 2, only the single point failures are considered, i.e. only those failures which could not and/or were not by-passed by some alternate hardware or technique. (See also Fig. 4.) Table 3 gives a description of these failures. It should be pointed out that the GDS antenna wheelhouse airconditioner faulted during both the AS-501 and AS-502 missions, but since the wheelhouse was operated in the ventilate mode with no restrictions in both cases, this failure was charged to the USB-System only once. It is believed that this is a conservative approach since operation was not affected in this case.
